Broad Creek Restoration Report
Friends of the Environment

In collaboration with Dr. Craig Layman (Florida International University)
Project Completed October 2010

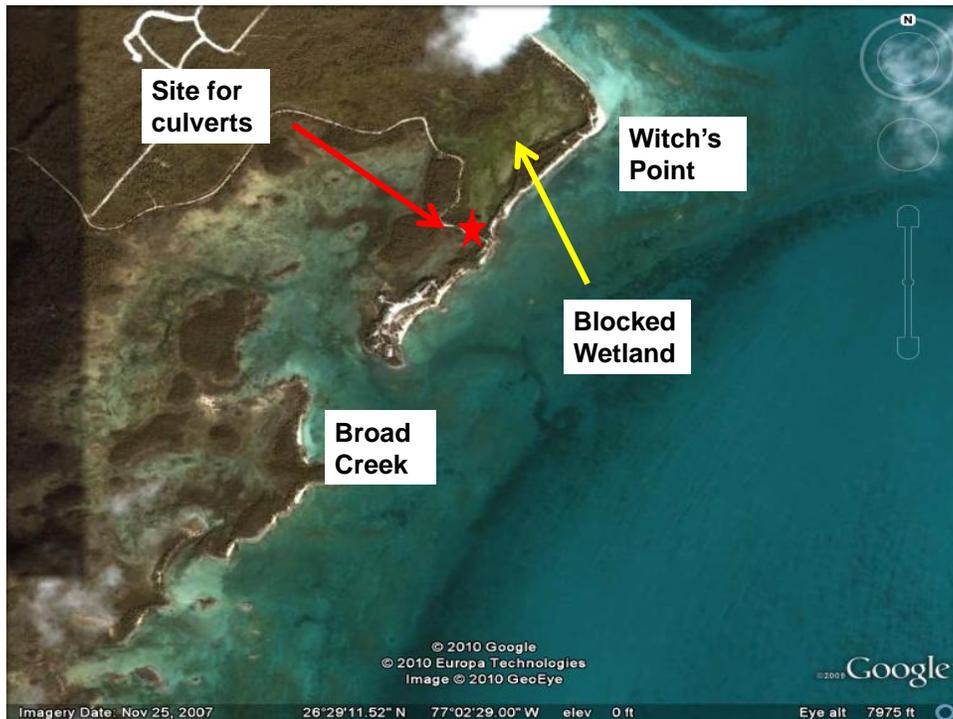
Figure 1. Aerial image of Broad Creek. The road to Camp Abaco blocks a large wetland to the northeast. Installation of culverts was intended to restore more natural tidal flow to the wetland area.

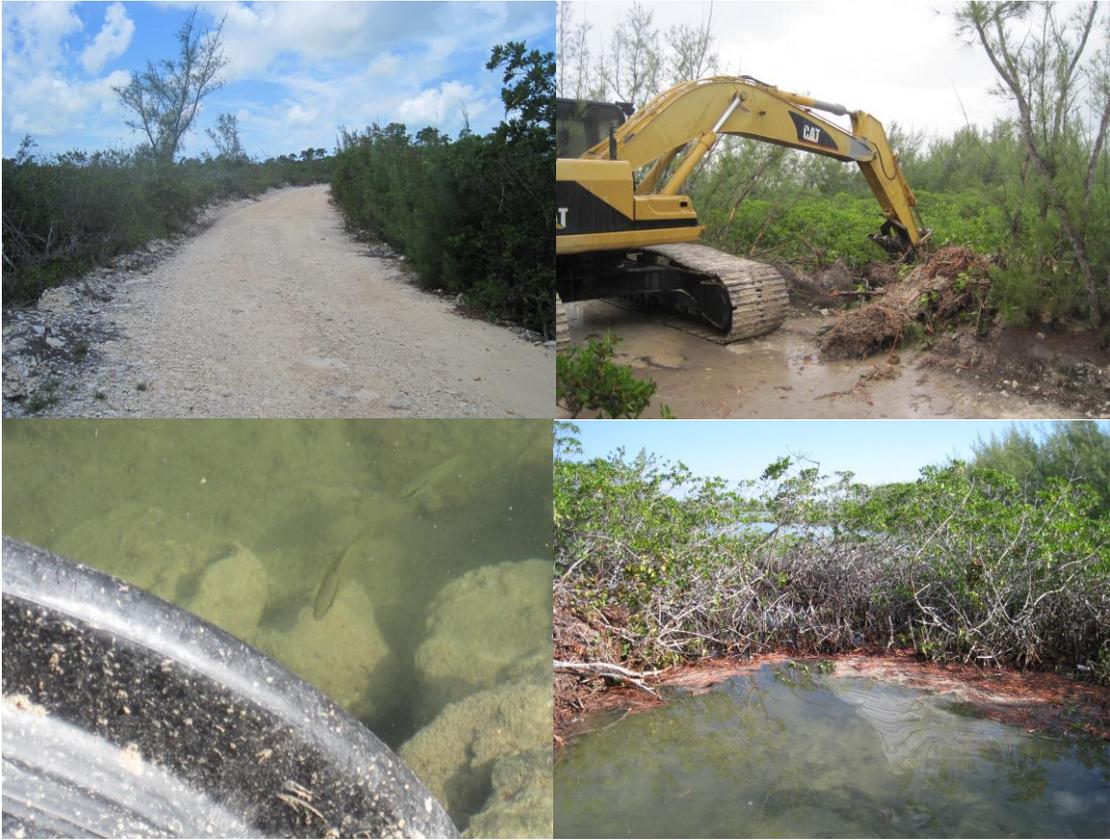
Figure 2. The road to Camp Abaco blocked 28 acres of wetland area (top left). The first step in the restoration was to remove the road, put the culverts in place, and then re-build the road. This step of the project was completed with an excavator (top right). Rocks were placed around the mouth of the culverts to stabilize the road and provide habitat for small snapper (bottom left). Areas were cleared on each side of the culverts to provide for freely flowing water (bottom right).

The Restoration: The restoration project was conducted in two phases. First, four 30” diameter culverts were installed under the road to allow tidal waters to again flood upstream areas (October 9th, 2010, see Figure 2 above). The culverts were positioned so that the high tide line reaches just above the top of the culverts. An excavator was used to remove this portion of the road, and subsequently infill the area around and above the culverts. Large rocks were placed on either side of the rebuilt road to prevent erosion from tidal flow. The excavator also cleared areas on either side of the road so that water could freely flow through the culverts. The bedrock layer was closer to the surface than at Cross Harbour (restoration in April 2006), so the cleared areas on either side of the culverts are not as deep as in the previous project. Small snapper were observed to move through the culverts the first day following the culvert installation. The rocky areas on either side of the road are expected to support dozens of small juvenile snapper (1-4 inch fish) within weeks.

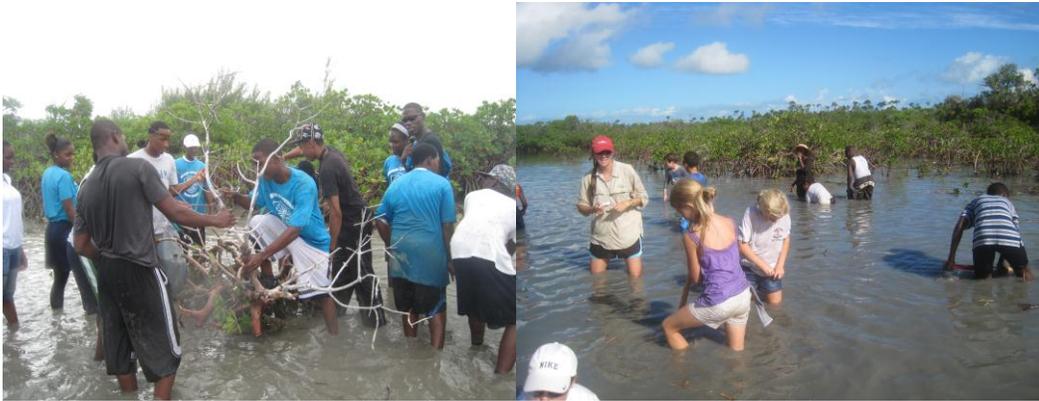
Figure 3. More than 500 Abaconians were involved with re-creating the historic tidal channels. Most of the schools on Abaco participated.

The second phase of the project provided the opportunity to extend the restoration to local students and community members (Figure 3). By hand (i.e., no heavy equipment was used), mangroves that had encroached into the historic tidal channel were removed. Mangroves are critical components of coastal tropical and sub-tropical ecosystems, and

their removal is an unwanted activity in almost all situations. However, this project was a focused effort to re-create the historic channel for water to flow freely, and ultimately we removed <0.1% of all the mangroves in the system. Approximately 510 Bahamians assisted with the channel creation, the majority of which were students. Most of the schools on Abaco had a chance to be involved in the project. Classroom lectures were coupled with the field trips to maximize the learning experience for the students. This was a true “win-win” situation: an extremely valuable project was completed for the environment of Abaco (at relatively low cost), while serving as a core educational tool.

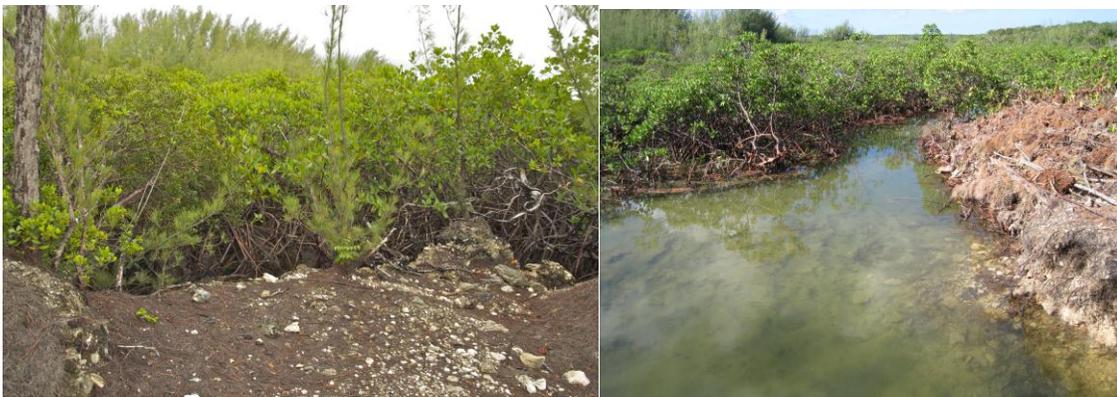
Figure 4. Before and after photos of the downstream portion of the creek. The cleared channel will provide for more natural tidal flow throughout the downstream wetland to the ocean, through the culverts and into the formerly blocked upstream areas.

In total, ~28 upstream acres were restored (Figure 4). These areas will once again become vital additional “nursery” areas for juvenile fishes and invertebrates. Larvae will ride high tides through the culverts and above the mangrove ridge to the upstream “pond” area. The connection with the ocean will allow them to ultimately move back to the ocean as adults and to join the breeding population. Additionally, the restoration re-created the historic tidal regime in the downstream portion of the creek system. Previously, the lack of tidal flow rendered the area too shallow to support populations of foraging fish. The restored channel substantially increases the available area for fish to feed, even in the portion of the system downstream of the road.
